## HLH ROTOR BLADE MANUFACTURING TECHNOLOGY DEVELOPMENT REPORT

Boeing Vertol Company  
P. O. Box 16858  
Philadelphia, Penn. 19142

September 1977

Final Report

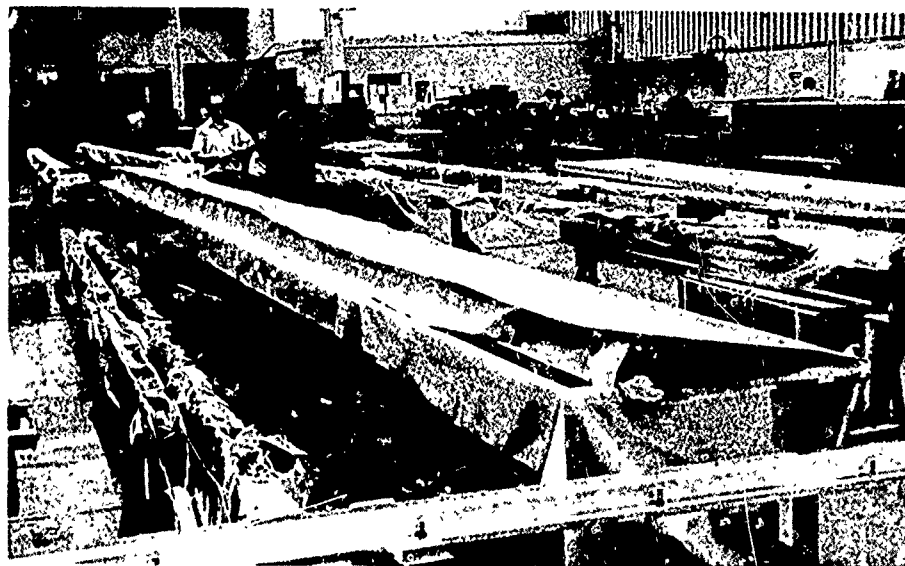
*Figure 91. Inspection Being Performed on Fairing Assembly After Skin-to-Core Curing Operation*

Core-to-Skin Subassembly. In the fairing bond fixture (VFM), the lower airfoil skin material is laid up, and the wedge-to-core subassembly is positioned over the skin. The subassembly is bagged and cured in the autoclave. After curing, the completed part is removed from the tool, trimmed, and inspected. (Refer to Figure 91.) The fairing is then ready for shipment to the core machining vendor. In the ATC program, the vendor utilized for this operation was the Hexcel Corporation, Graham, Texas.

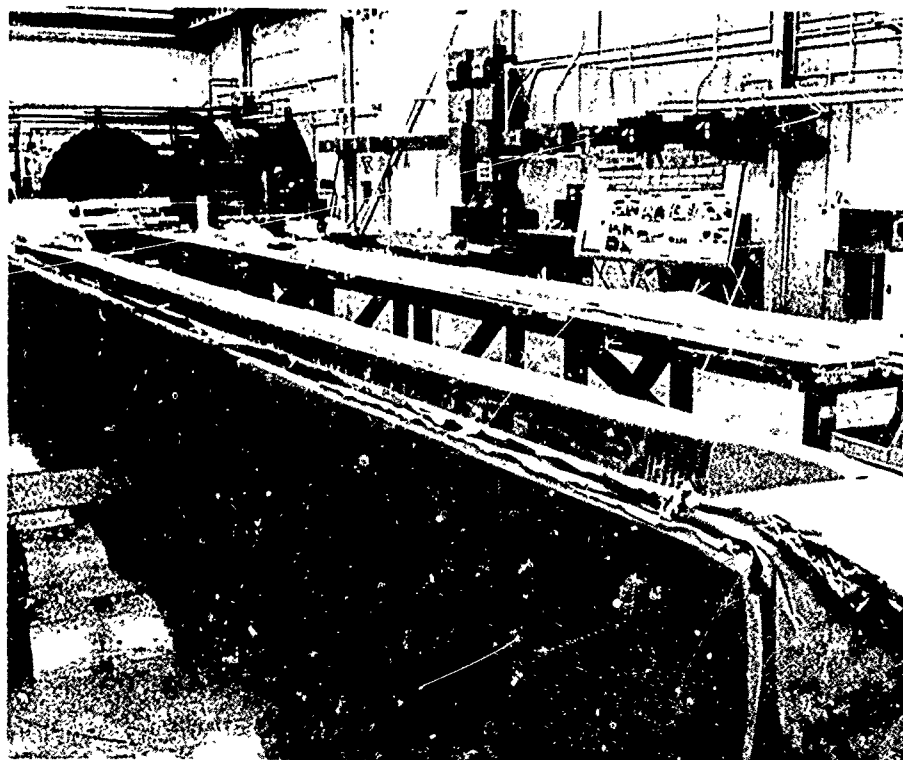
*Figure 92. Fairing Assembly Machined and Ready for Bonding on Blade No. 1*

Core Machining Operation. The machining operation includes the upper contour and the leading edge cut, referred to as the "V notch". (Refer to Figure 92.) After machining, the upper surface requires hand sanding to blend the core and trailing edge wedge in a smooth transition. The size of the part, the variations in geometry, and the tolerances required made this one of the most difficult parts that we have attempted to machine for bonding.

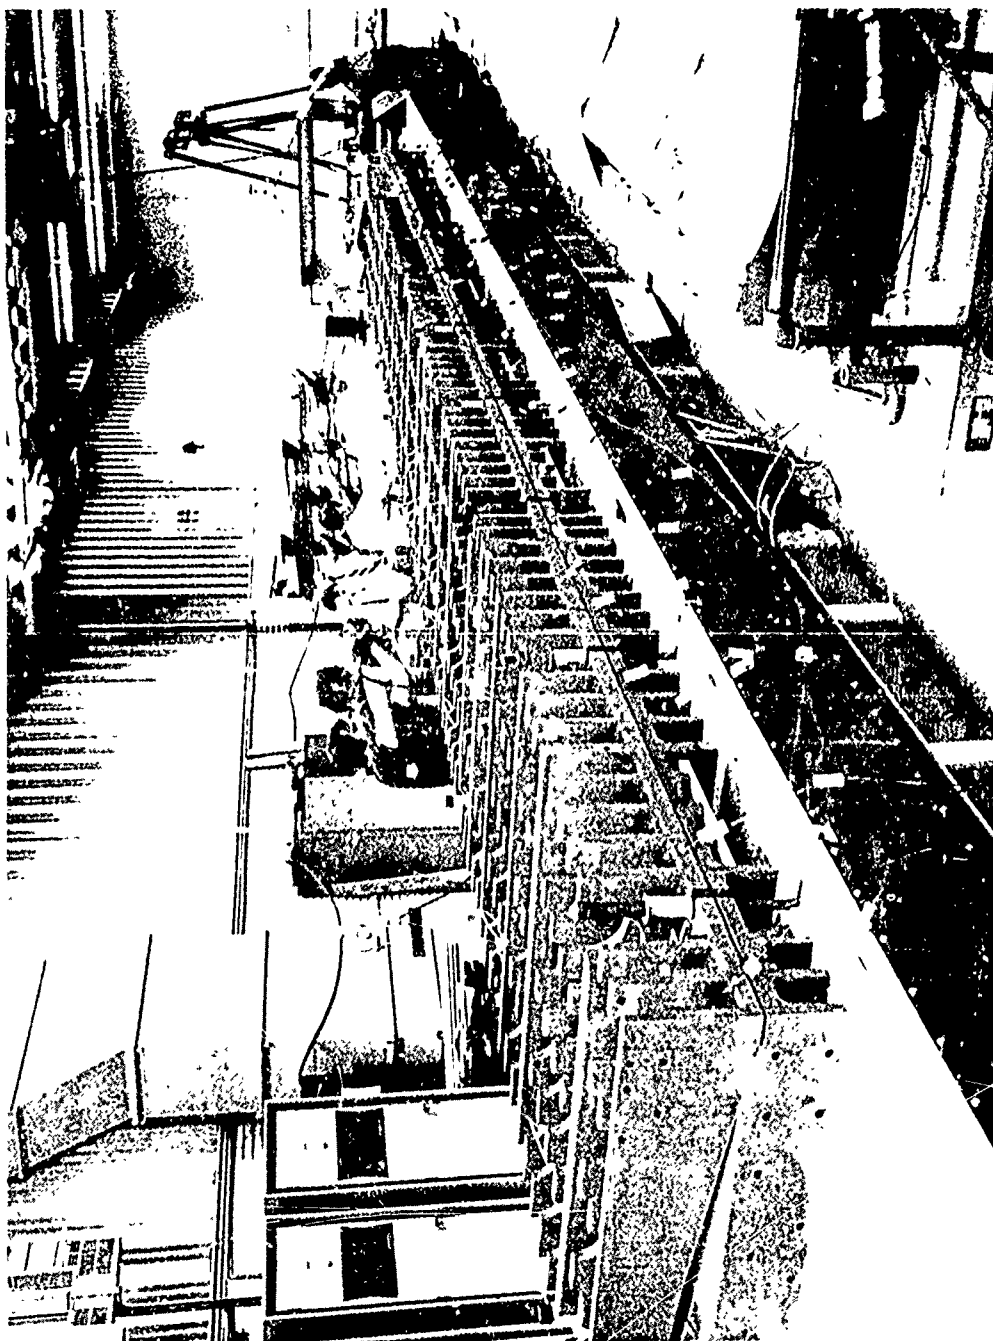
*Figure 93. Main Bond Tool Being Closed*

After installation of the spar fittings, the next major operation is bonding of the fairing subassembly and spar subassembly into a bonded blade assembly in the main blade bonding fixture (BAJ). The operation begins with a pre-fit check of the spar in the main bonding fixture. This is followed by a pre-fit of the fairing assembly. Measurements are taken at critical points to ensure proper closing of the tool. (Refer to Figure 93.) The main bond fixture is then unloaded, and the upper airfoil skin is laid into the bottom half of the fixture. An internal mandrel is positioned inside the spar, and both ends of the spar are sealed. The internal mandrel is required to provide positive support for the spar heel during the cure operation. The spar and fairing are then positioned in the fixture, together with the required adhesives (FM37 and EA9628). Next, the upper halves of the tool are placed over the assembly and secured. The computer-controlled heating elements are connected, and the curing cycle started. After the cure, the bonded blade is removed from the fixture, and the outboard end (test article) is trimmed off. The spar seals are removed, and the internal mandrel is extracted. At that time the trailing edge tool coordination holes are no longer required and the entire aft edge is routed off to the proper chordal dimensions. (Refer to Figures 94 and 95.)

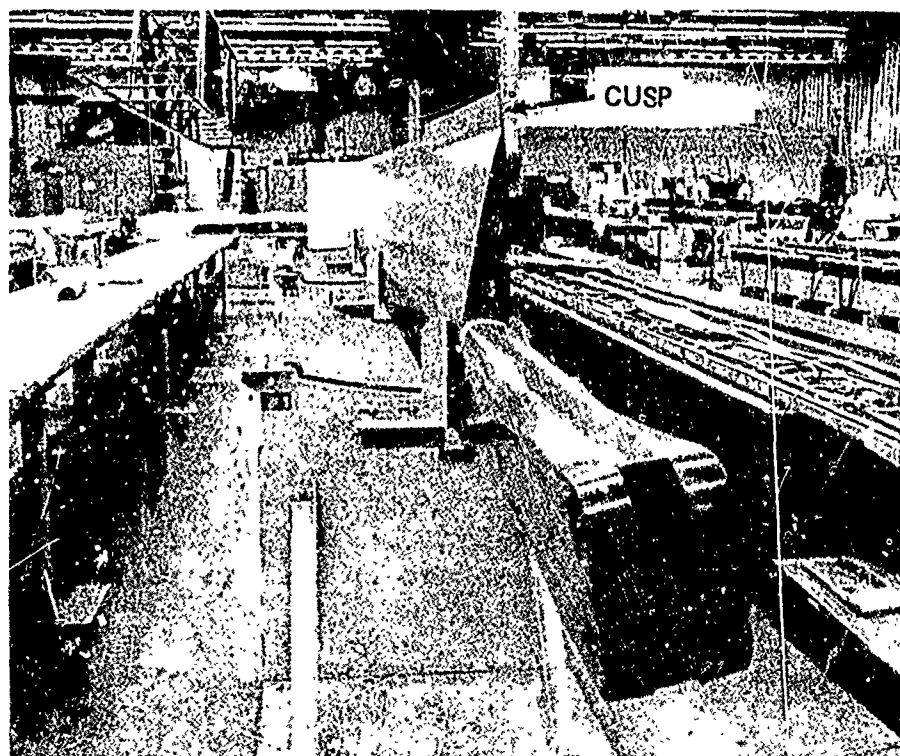
*Figure 95. Blade No. 1, Showing Trailing Edge Cusp and Blade Twist*

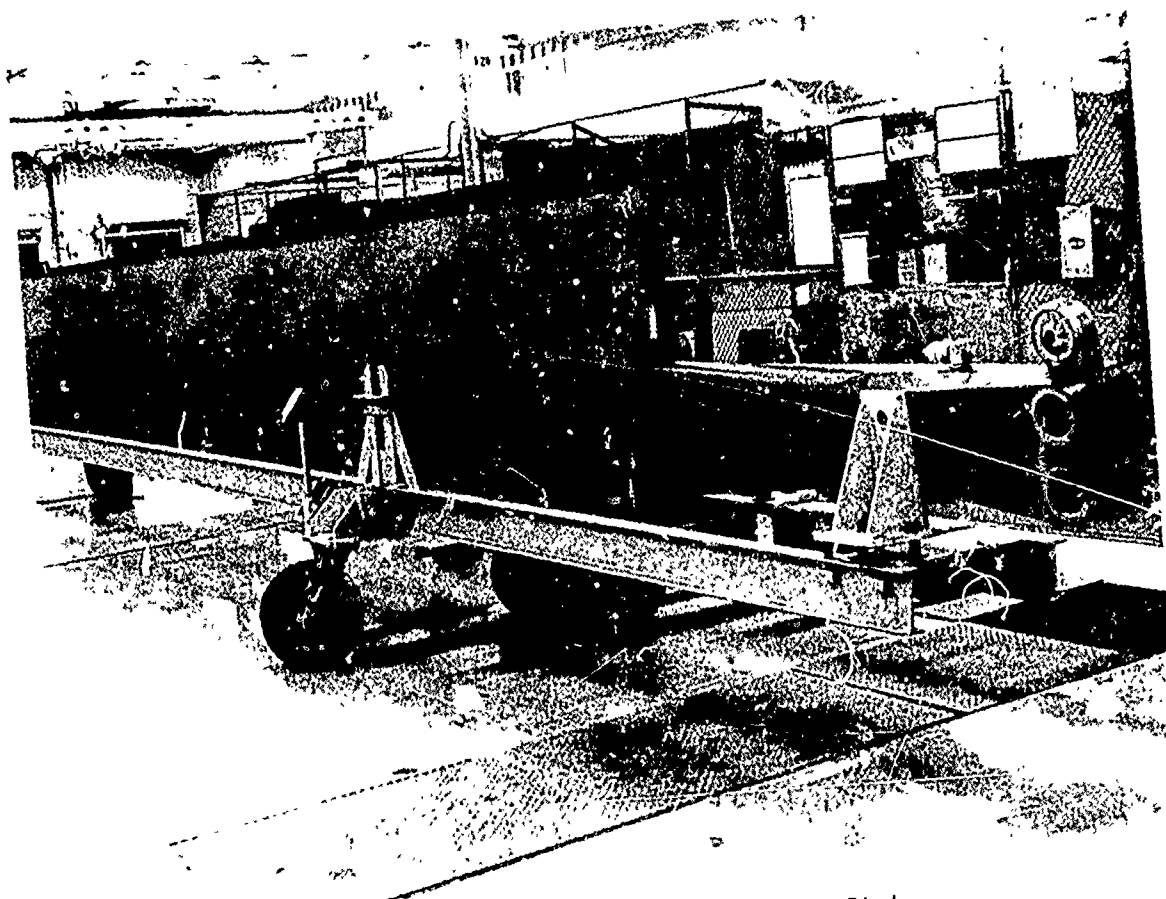
Figure 96. Root End View of Completed Blade

Final assembly of the blade includes boring the root end, installation of blade hardware, activating the Integral Spar Inspection System (ISIS), painting, and teeter balance. The blade hardware consists of the trim tabs, tie-down fitting, tip cover, inboard and outboard ribs, inboard ISIS bulkhead, teeter hardware, ISIS mount, ISIS indicator and valve, inboard bulkhead, damper fitting, sleeves, washers, erosion cap, lightning protection and tip targets. (Refer to Figures 96 and 97).

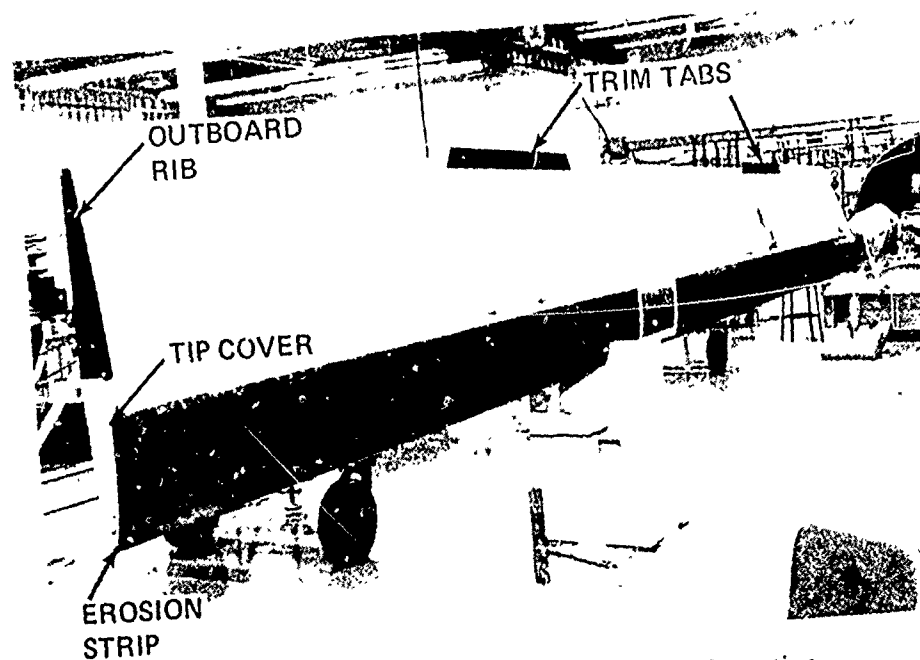
Figure 97. Blade No. 2 in Final Assembly Operation

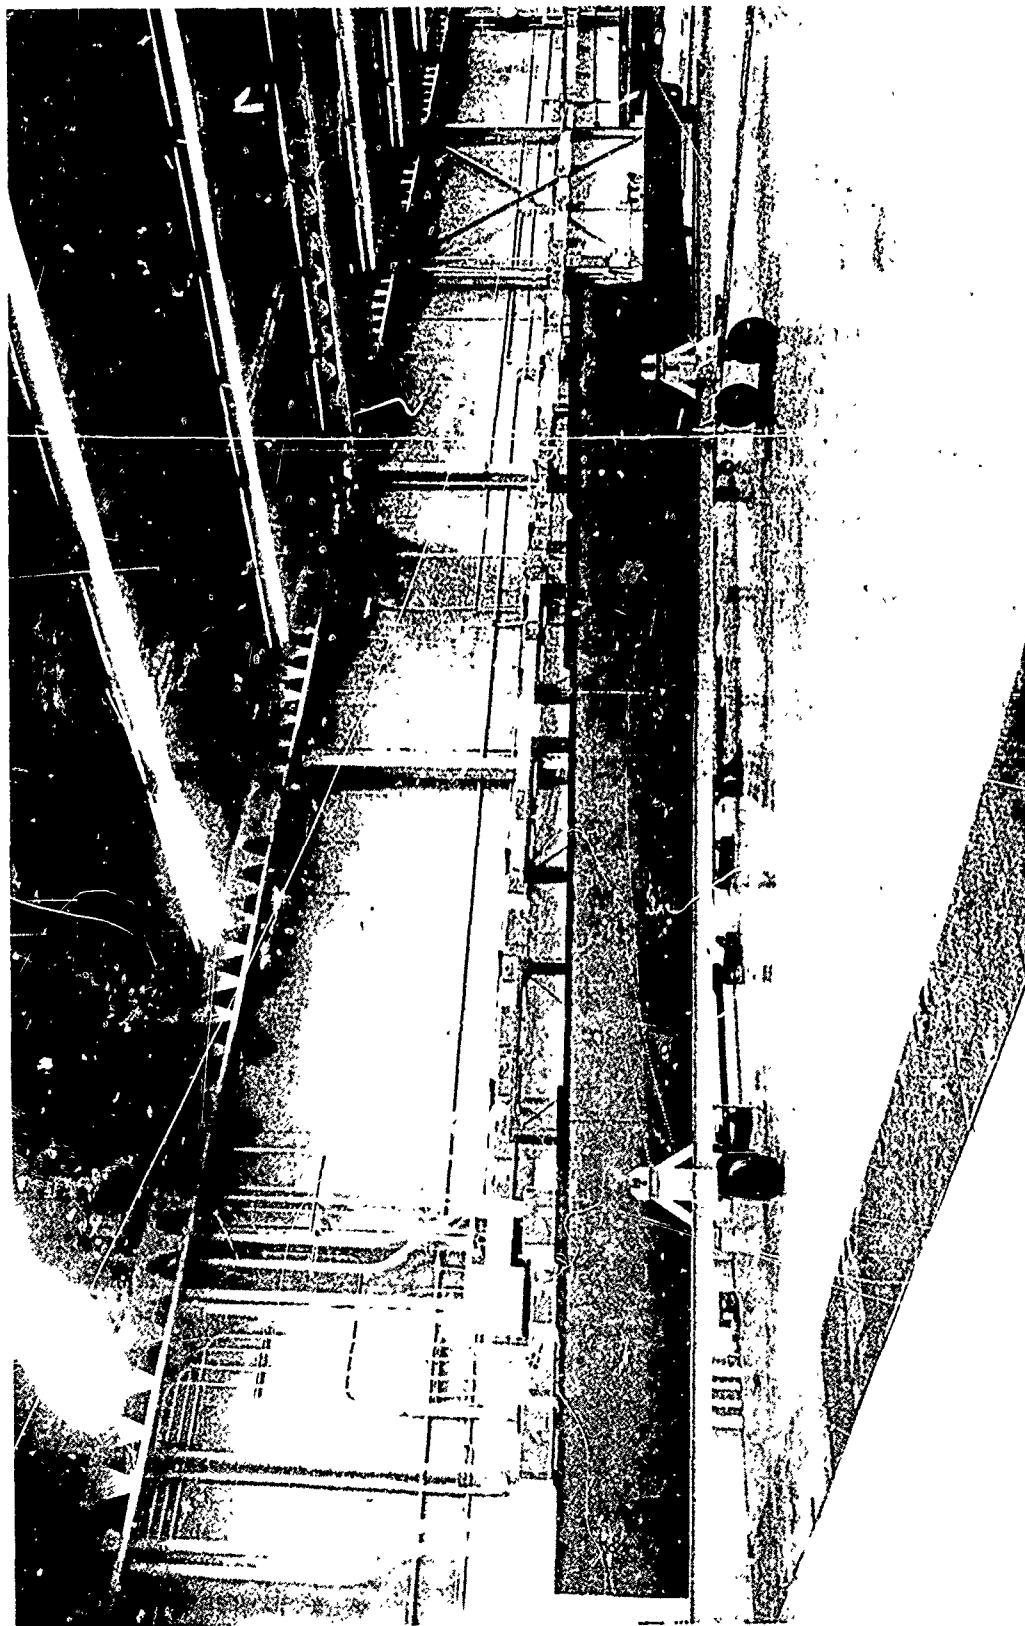
Figure 98. Blade No. 1 After Boring Operation Complete

The boring and counter boring of the holes in the root end of the blade are performed in a special boring fixture designed for the HLH blade (Figures 54 and 98). This fixture is also used in aligning the lag damper fitting in the root end of the blade and the installation of the sleeves. In

boring these holes, a problem was encountered with the cutting tools not producing a smooth finish, and the counter bores tended to be oval shaped. With some experimentation, the ideal cutter configuration was identified and used with good results.

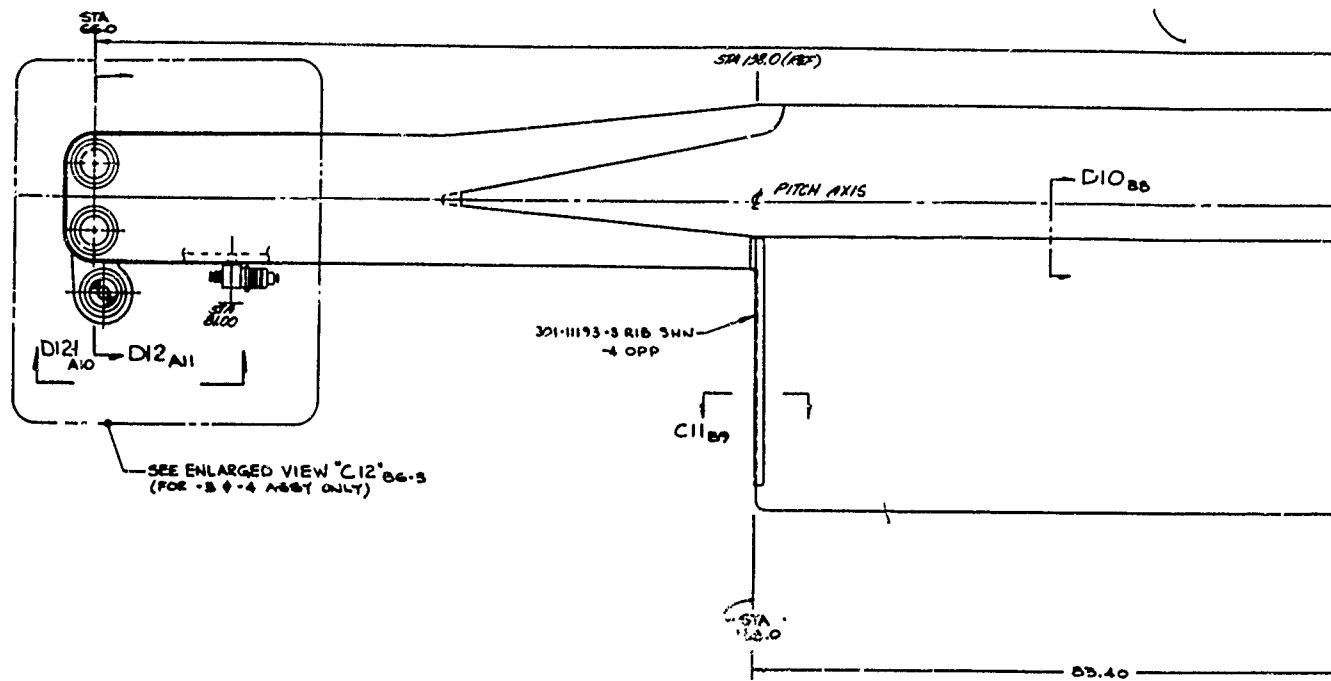
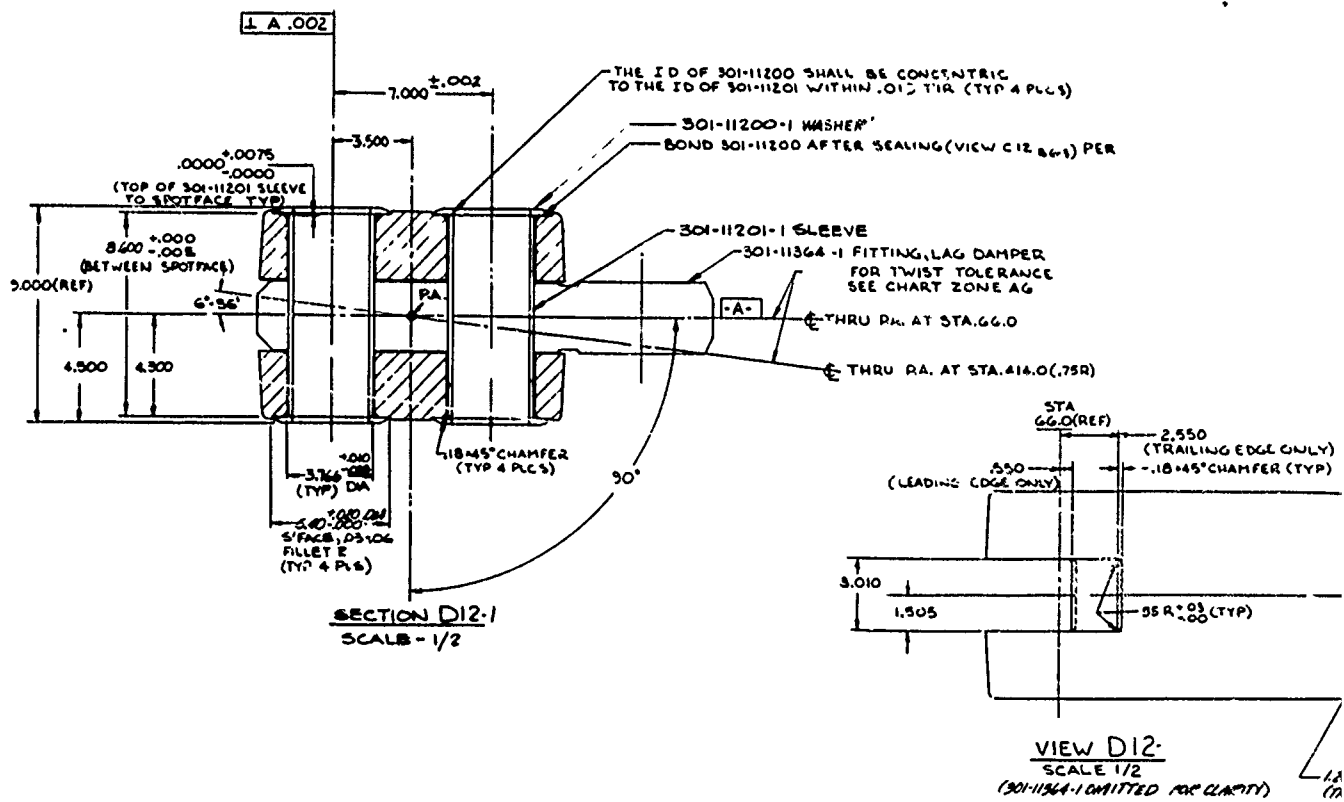
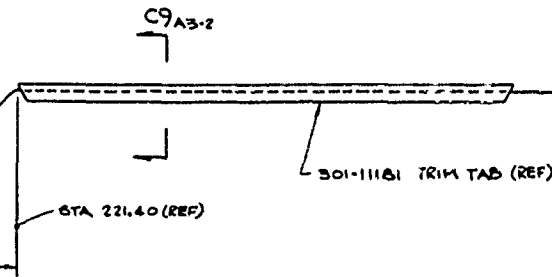
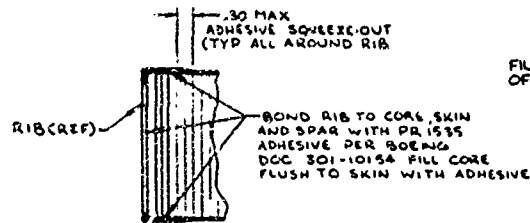
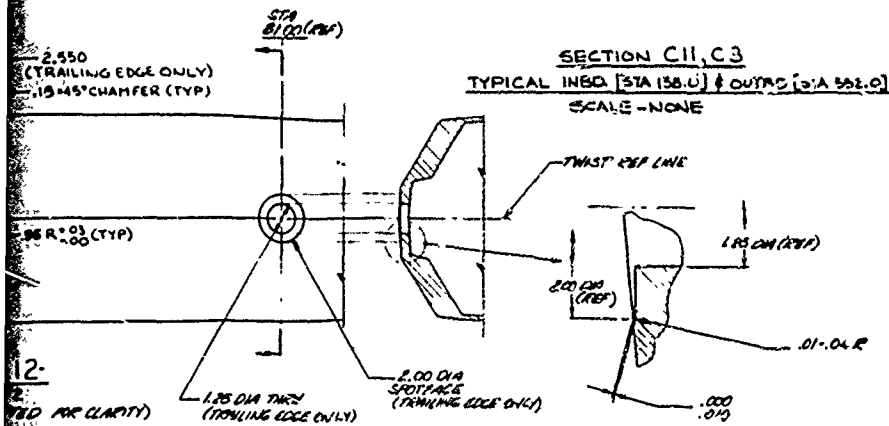
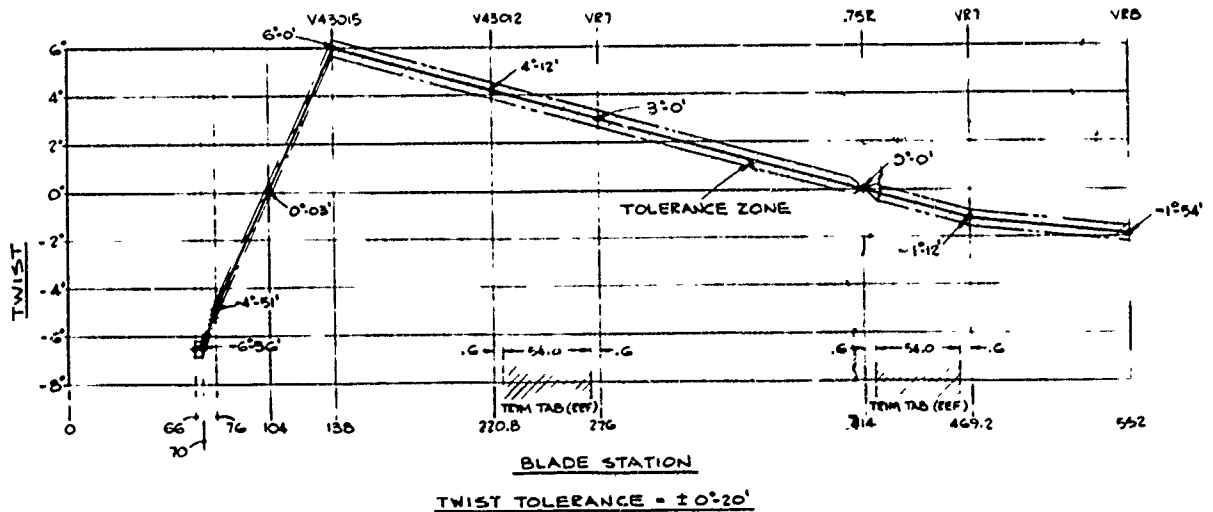
Figure 99. HLH Rotor Blade Assembly (Sheet 1 of 3)

- MITTED FOR CLARITY
- 1 BLADE ASSEMBLY, AFT (SHOWN)
  - 2 BLADE ASSEMBLY, FWD (OPP-1)
  - 3 BLADE ASSEMBLY (SAME AS -1 EXCEPT DETECTION SYSTEM INSTALLED)
  - 4 BLADE ASSEMBLY (SAME AS -2 EXCEPT DETECTION SYSTEM INSTALLED)

At this point, the ISIS system is leak-checked as described in the Quality Assurance section, since the inboard bulkhead becomes inaccessible after the lag damper fitting is installed. The spar cavity is pressurized to 2.0 psig with helium, and the entire spar is checked with a leak detector. Any discrepant conditions are reworked and the spar is then evacuated to 7.5 psia. After evacuation, the ISIS valve is closed, capped and torqued. The ISIS system is monitored for a specified period to ensure against any minute leaks.

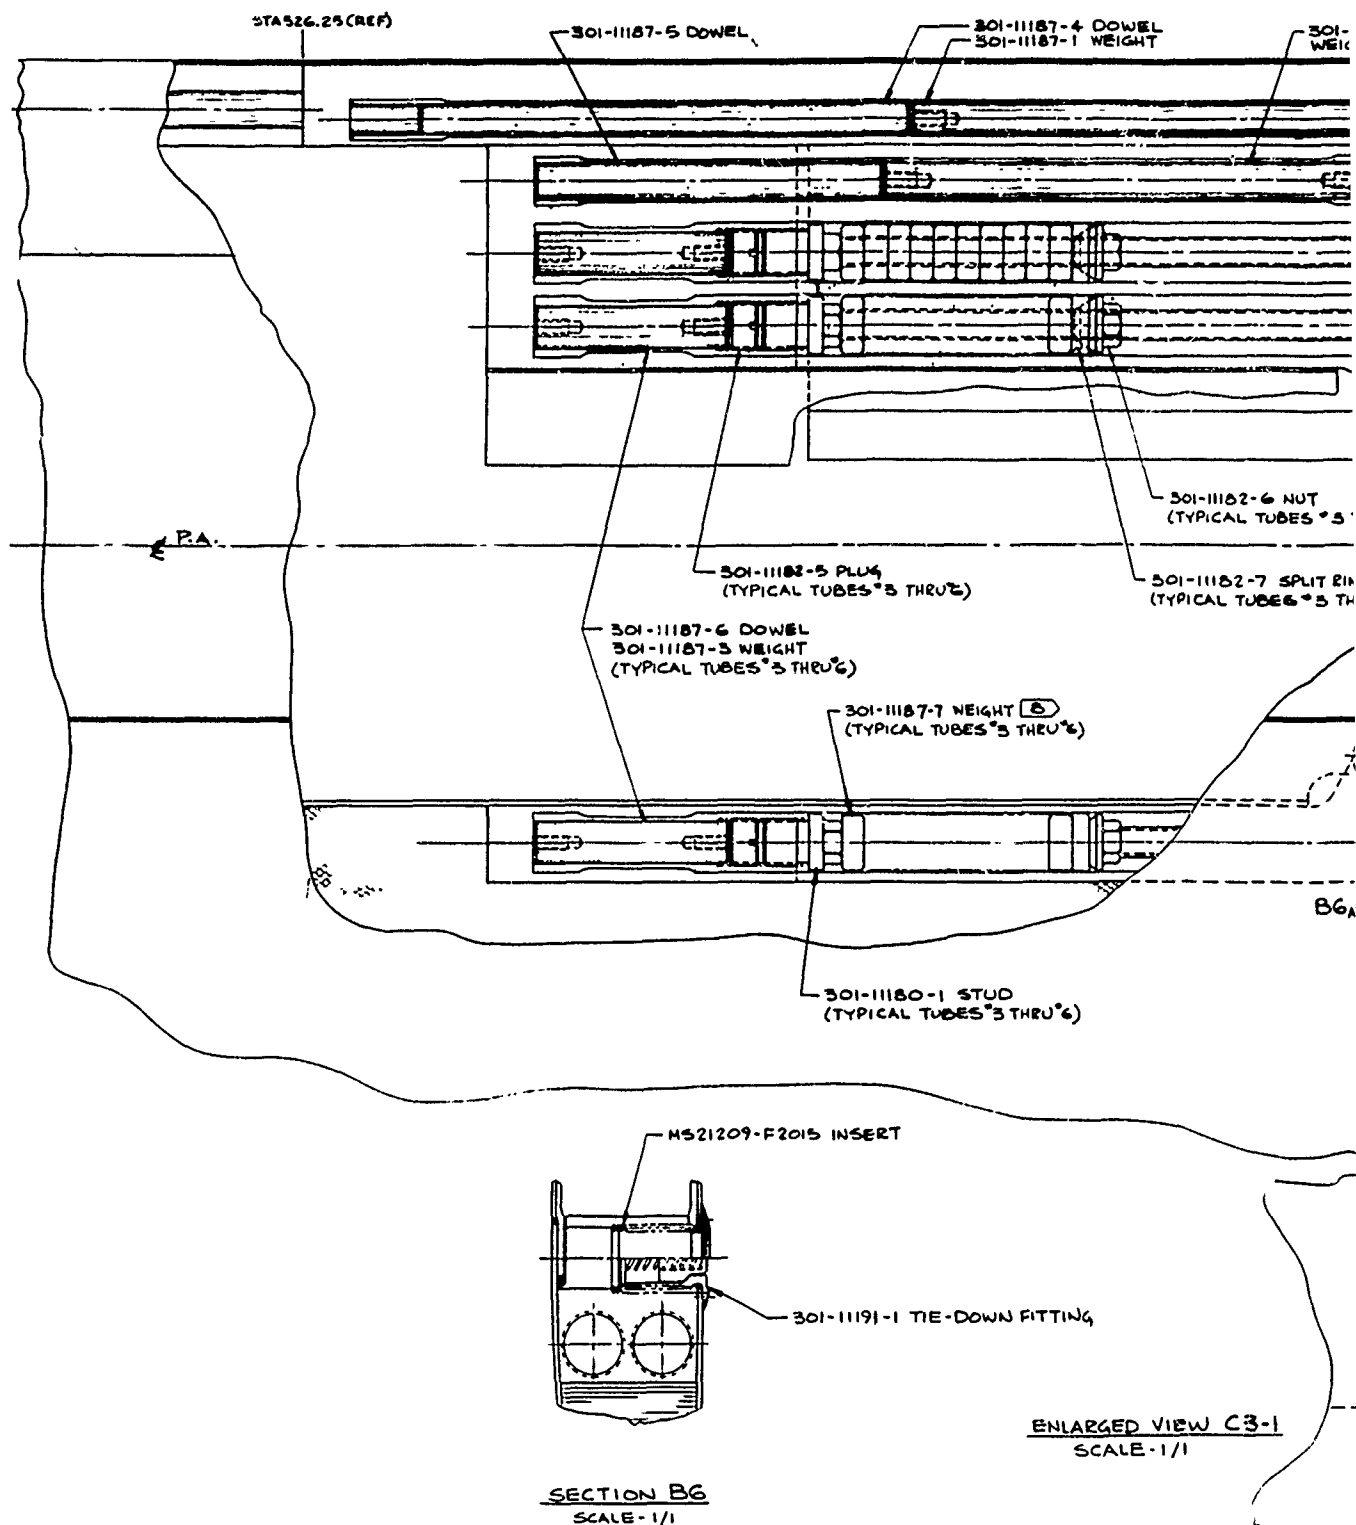
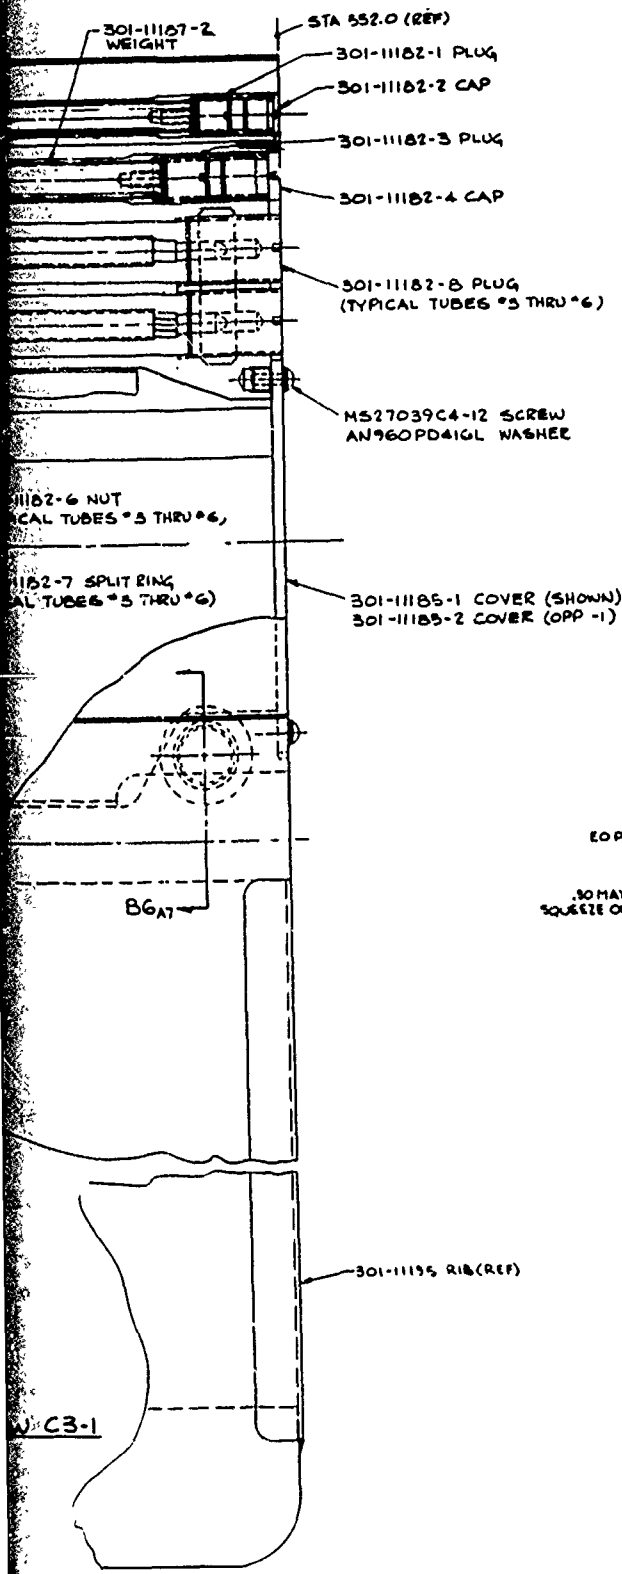
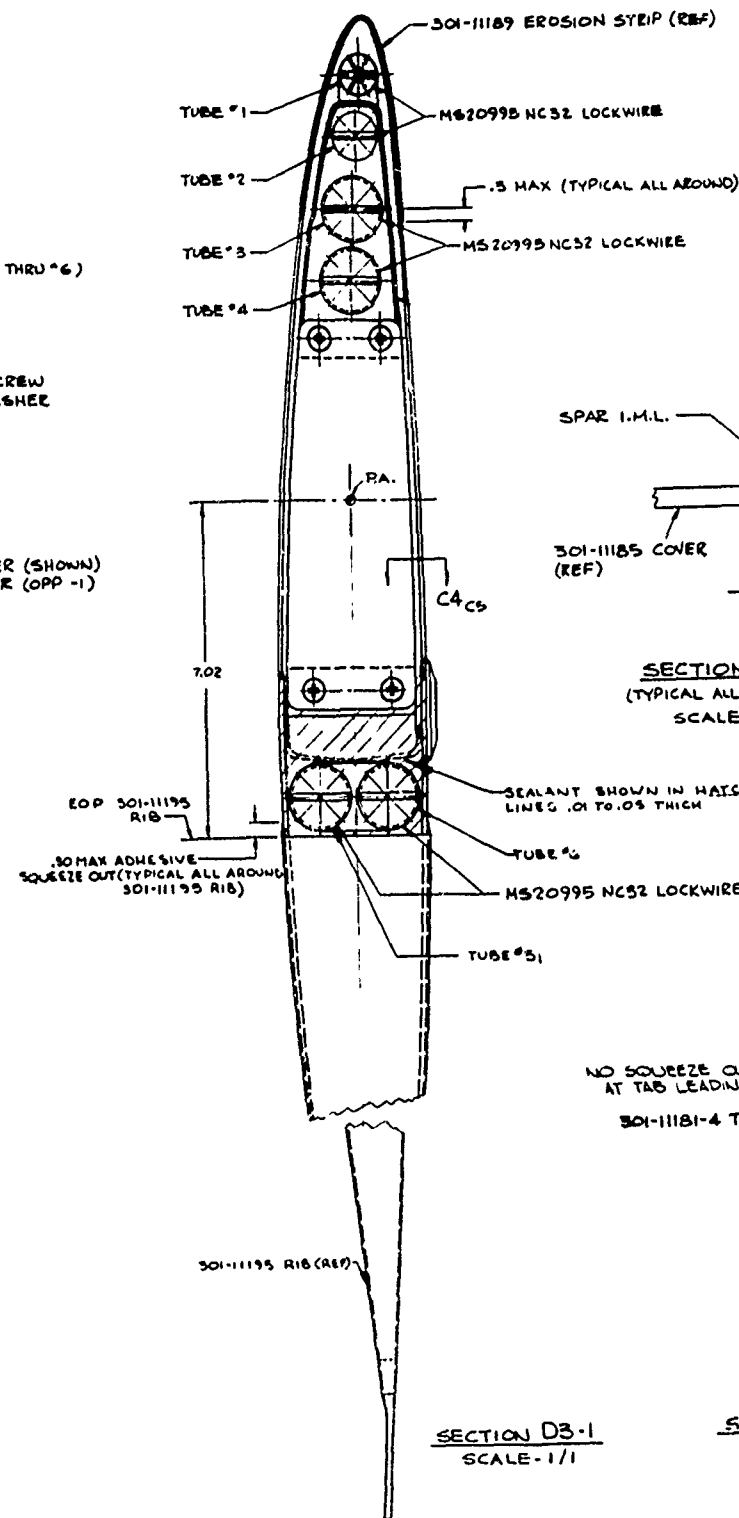
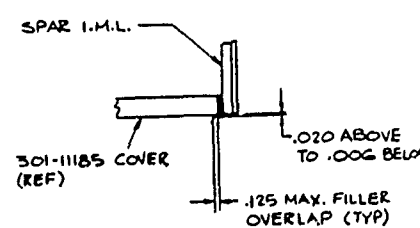
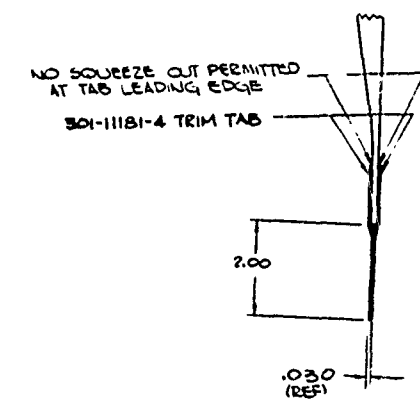
Figure 99. HLH Rotor Blade Assembly (Sheet 2 of 3)

**SECTION C4**  
(TYPICAL ALL AROUND COVER)  
SCALE - NONE

**SECTION D3-1**  
SCALE - 1/1

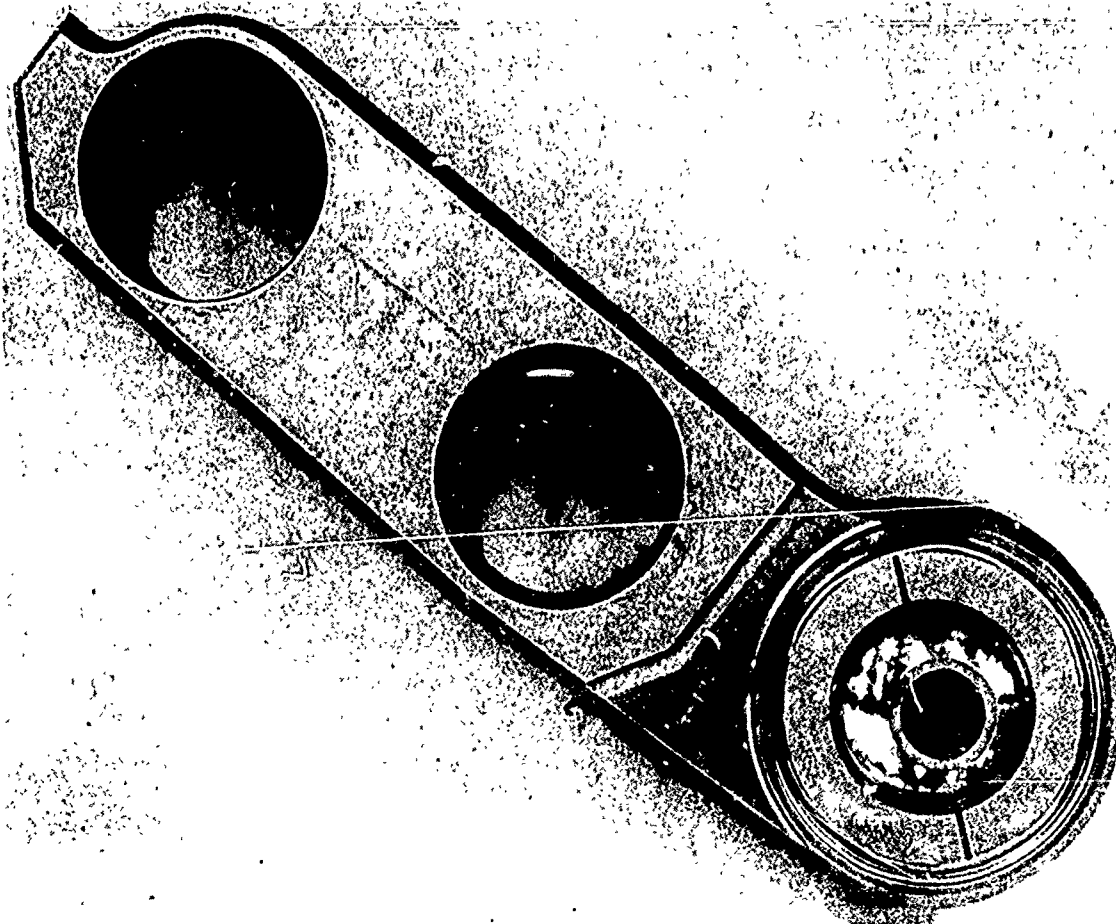
*Figure 100. Lag Damper Fitting*

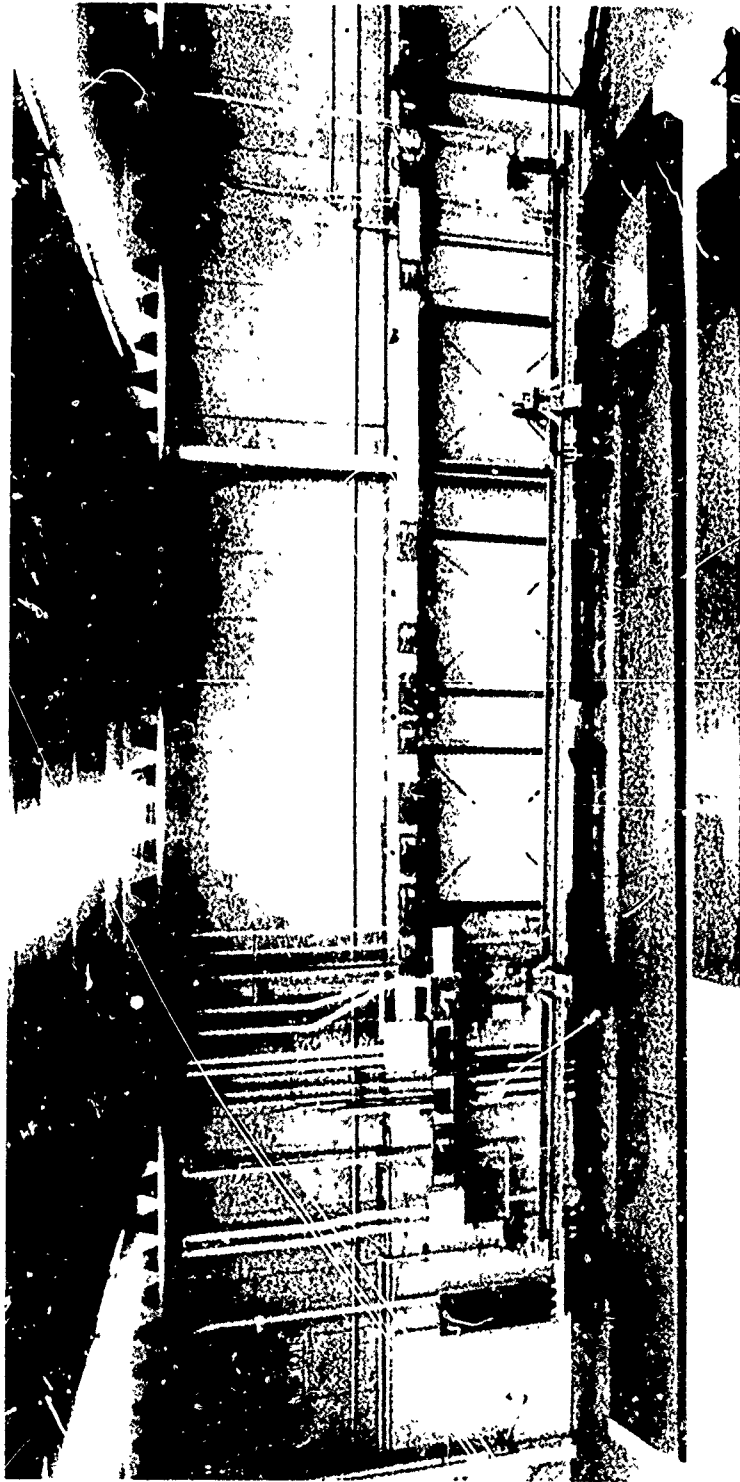
*Figure 101. Size Comparison Between I-LH Blade No. 1 and CH-47 Production Blade*

The variation of weight between the lightest and heaviest blade was 5 pounds after teetering or less than 1% of the specified blade weight. Figure 101 is a size comparison between the HLH and CH-47 rotor blades.

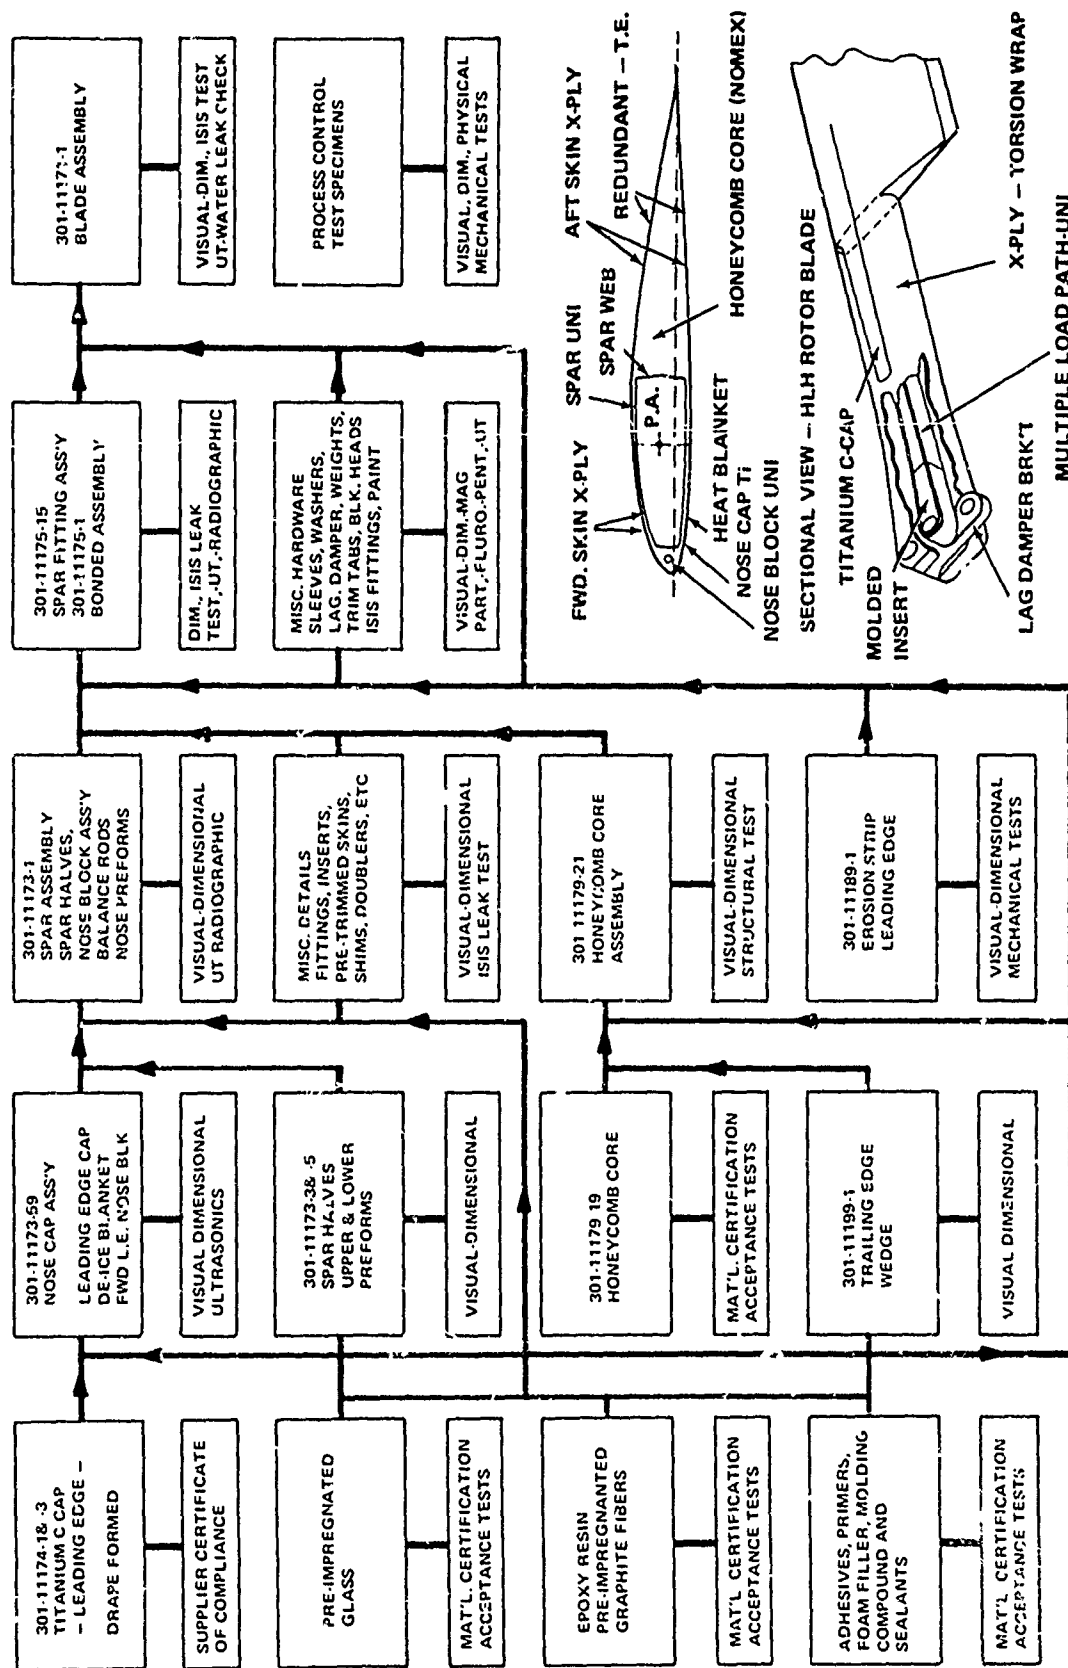
Figure 111. Quality Assurance Flow Chart

The basic element of the Capability Analysis was the Quality Assurance Flow Chart, Figure 111, which shows schematically the processes involved from the receipt of materials to final assembly of the blade. Each major block in the flow represents a step in the fabrication sequence at which controls and inspections are required. Figure 112 shows the details and physical relationships of the blade components.

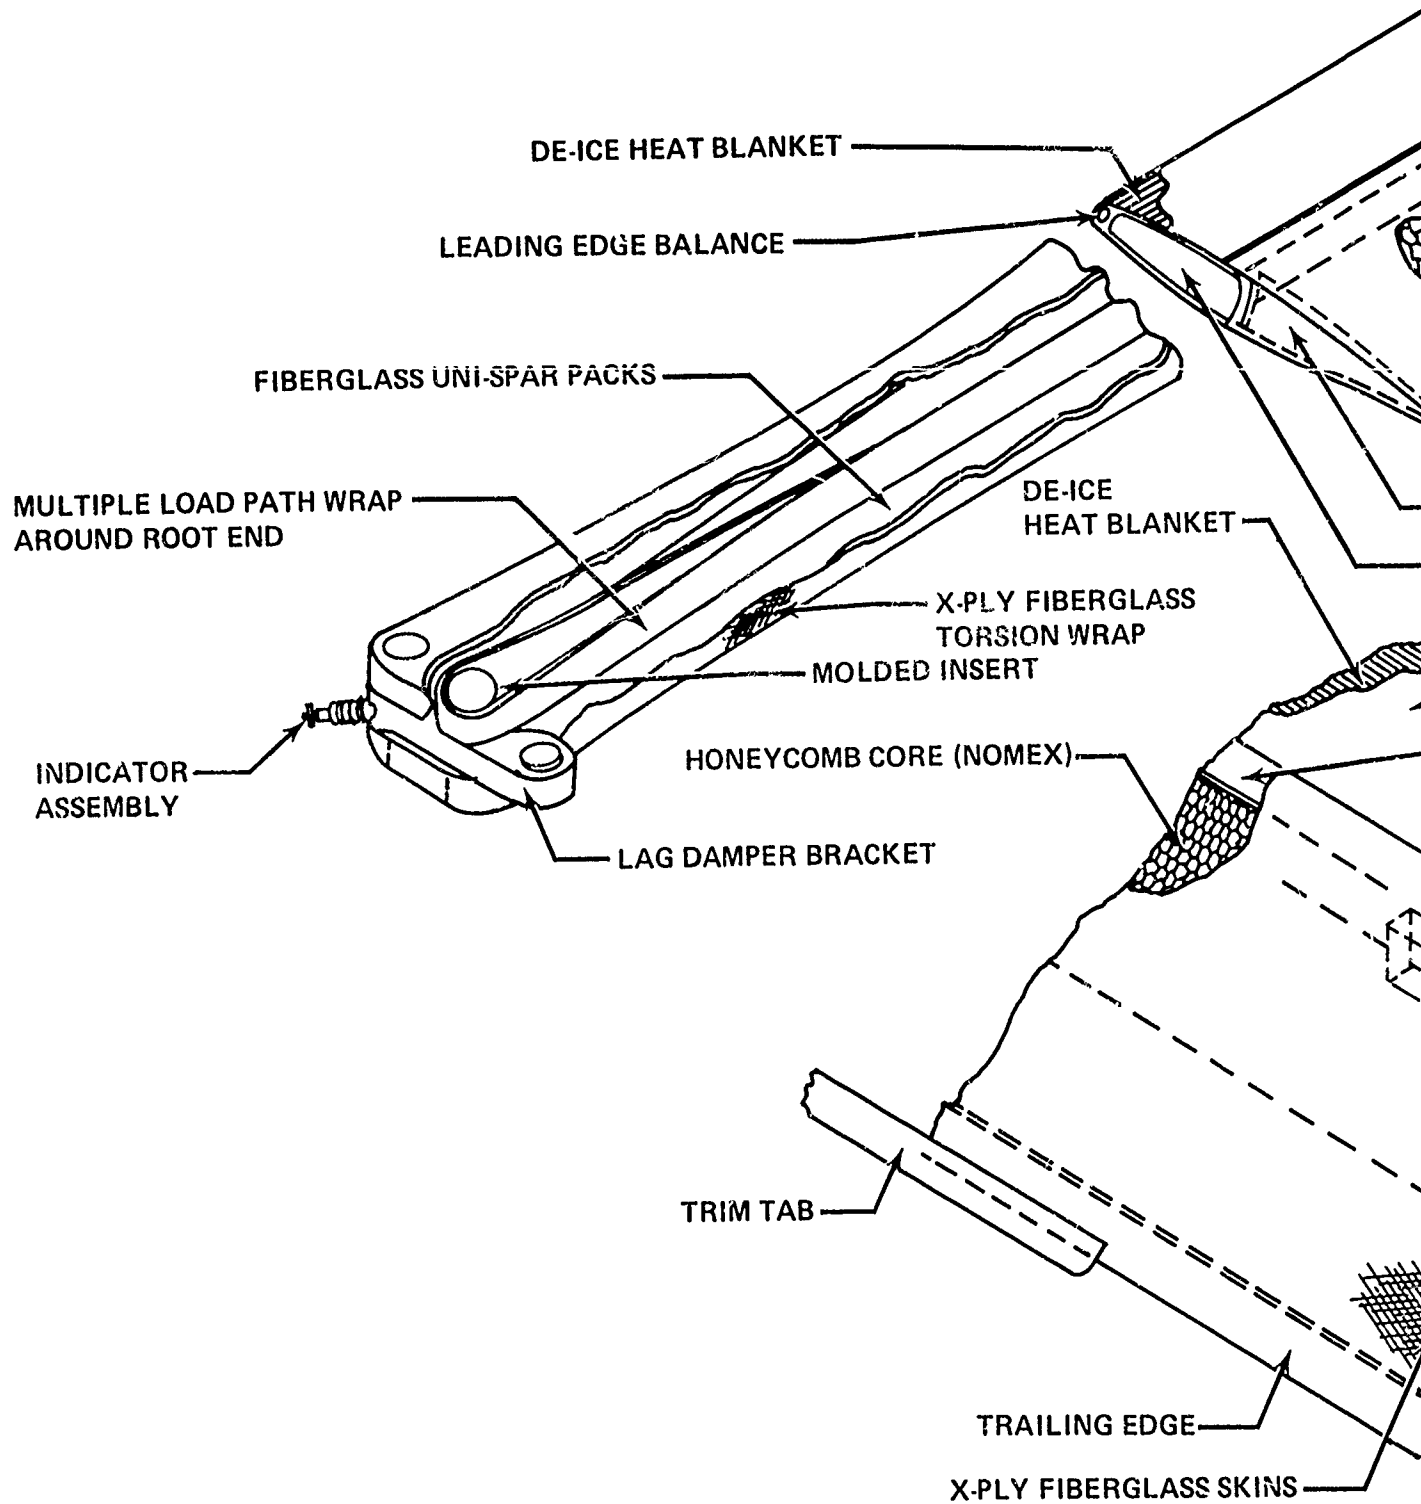
Figure 112. HLH Rotor Blade Components

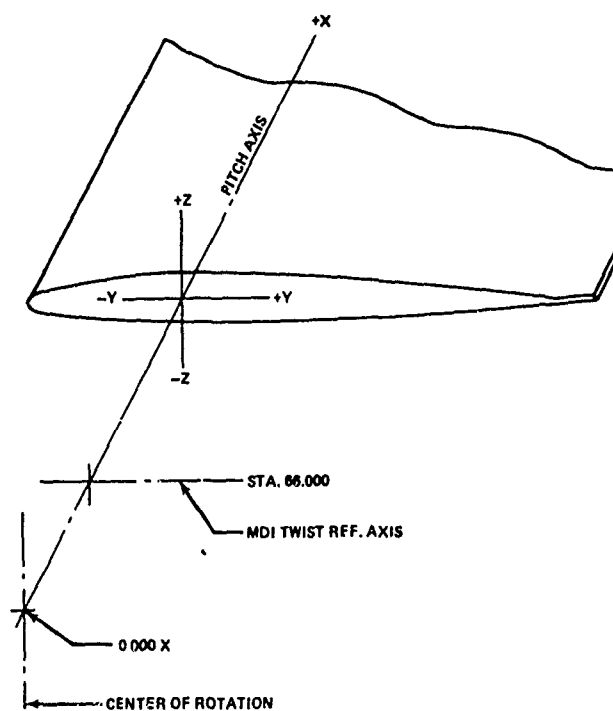
Figure 114. MDI Coordinate System and Axes Orientation

Two rotor blade root end specimens were made to establish fabrication method and to provide test specimens for the development program. The required quality level of the root end specimens was maintained by monitoring the types and conditions of materials, and by accurately controlling temperature, pressure, and cure cycle during material lay-up. The completed specimens were dimensionally inspected to make certain that the cross-sectional contour and the spanwise twist met the requirements of the Master Dimension Identifier (MDI); i.e., to verify that the Y-Y and Z-Z coordinates of the contour were as specified by the MDI at several blade stations. Figure 114 shows the MDI coordinate system used in making the dimensional measurements.
